An evaluation, using a "three-point bending" test, of the fatigue resistance of certain fiber posts

Simone Grandini DDS, MSC*, Cecilia Goracci, DDS, MS, MSC**,
Francesca Monticelli, DDS***, Andrea Borracchini, MD, DDS****,
Marco Ferrari MD, DDS, Ph D*****

University of Siena

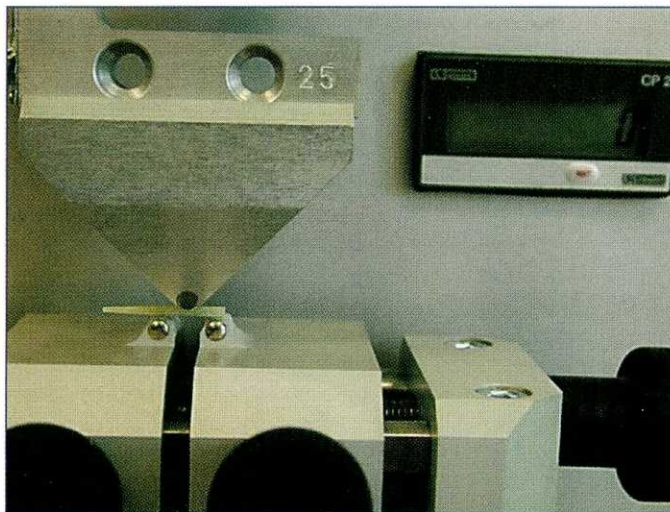
1. The post ready for the test.

Ten posts in each Group underwent a fatigue test by means of a special machine (Procyon Systèmes, France). This machine has a counter that measures the number of cycles and that stops when

and if the sample breaks (figure 1). A three-point bending machine, loaded at an angle of 90° and a frequency of 3 Hz, was employed for fatigue testing. Because the posts of the 6 groups had different diameters, a mathematical formula was used to calculate the force to apply on the different posts in accordance with the diameter of the post and therefore, proportionally to it. The two supports and the punch had a diameter of 3 mm, and the distance between the two supports was 9 mm. All the tests were carried out at room temperature, approximately 22°C. The machine was calibrated to reach 2,000,000 cycles: it was observed that teeth touch once a minute on average and that therefore this number simulated four years of clinical functioning of the post, which means of physiological chewing functions^{5,7}.

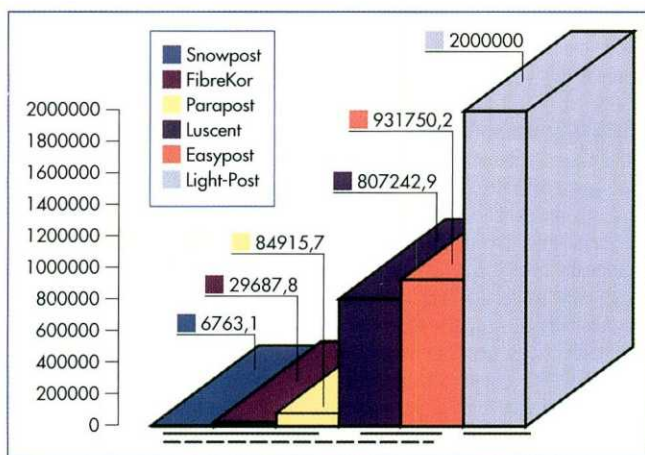
2. Graph showing the average number of cycles that the posts in the 6 groups withstood. The columns underlined by the same line did not display any statistically significant differences.

Table 2 shows the averages and the standard deviation of the number of cycles withstood by the different types of post. The results of the statistical analysis were summarized in figure 2.

The highest resistance to the test was shown by the DT Light-Post group (Group 4). None of the samples belonging to this group fractured after two million cycles. From a statistical point of view, none of the other five groups provided similar results (figure 2). On the other hand, Snowpost, FiberKor, and Para Post (respectively Groups 6, 3, and 2) showed resistance values to fatigue that were significantly lower than all the other groups that were tested (figure 2).

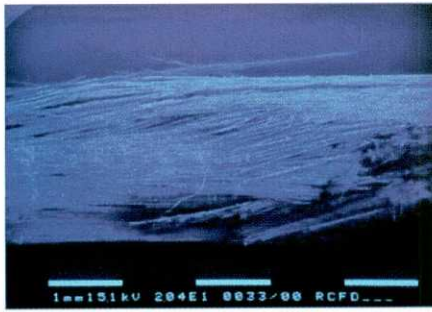
3. Sample of Group 6 after the fracture following the fatigue test. The separation between the fibers and the resin matrix is evident.

Once the posts fractured during the fatigue test the loss of structural integrity became evident. In different ways and to different extents separation between the fibers and the matrix (figures 3 and 4) became evident in Groups 1, 2, 3, 5 and 6. On the contrary, the samples in Group 4 showed a small circumferential depression on the external surface, at the point where pressure was applied by the punch, without other apparent morpho-structural variations (figure 5).

The brief and unstructured SEM evaluation that was carried out in this study seems to indicate that the posts in Group 4, which are those that gave the best results, also a good surface structure, a good bond between the fibers and the resin and the absence of structural defects. In another study³² it was noticed that the above-mentioned factors, if compared with one another, are a good indication of whether they can or cannot withstand the fatigue test. Indeed, the posts with evident structural defects gave quite negative results. Adhesion between fibers and matrix, which seems to be very important to determine fatigue resistance, is difficult to evaluate. Some speculation can be made from the images of the posts that are fractured or not, where it is evident how the strength of the bond between the fibers and the matrix is different in the 6 groups that were examined and greatly influences the final result. In some cases, after the fracture, it was clear that this bond was almost completely absent (figures 3-5).

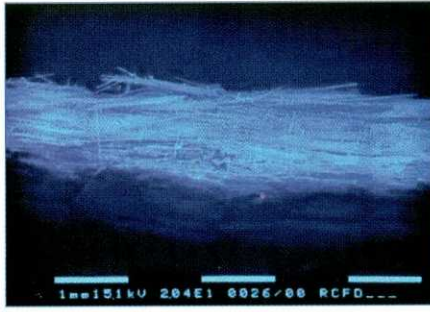
4. Sample of Group 2. Here too the fracture shows the failure of the bond between the fibers and the resin matrix.

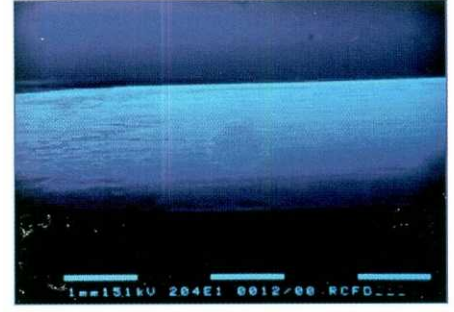
5. Sample of Group 4. After 2,000,000 cycles the post is still intact. The point at which the load was applied is evident, with a small depression in the middle of the post, which in any case remains perfectly intact from a structural point of view.
