Round-Flared-Oval Fiber Post

Step By Step Clinical Technique

- Canine incisor with a failed composite restoration.
- Restored with Macro-Lock Oval #3
- Cemented with Sealbond Ultima and Corecem

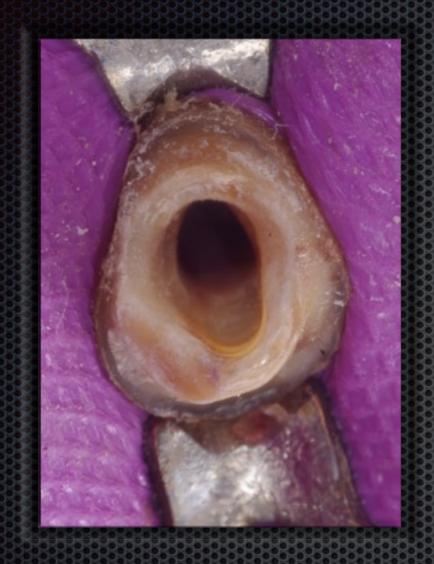
Prepare post space: Starter Drill and then sequential Finishing Drills

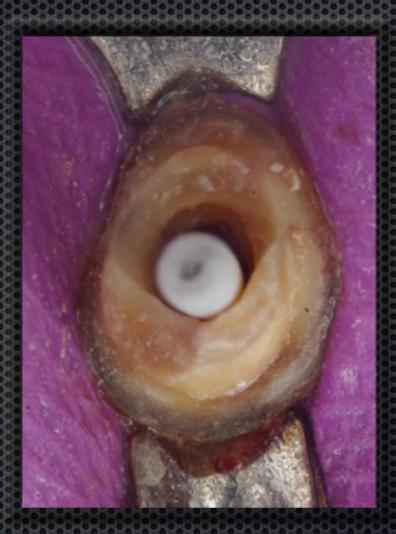
Prepared post space

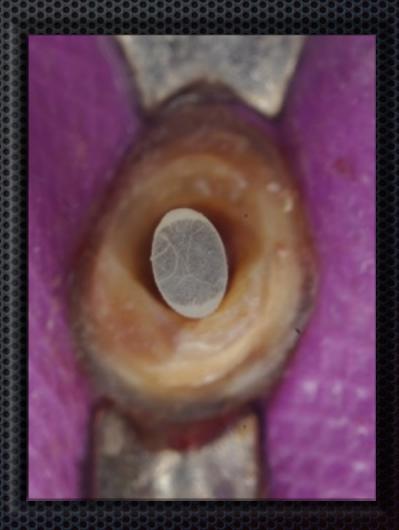
Round post does NOT FIT

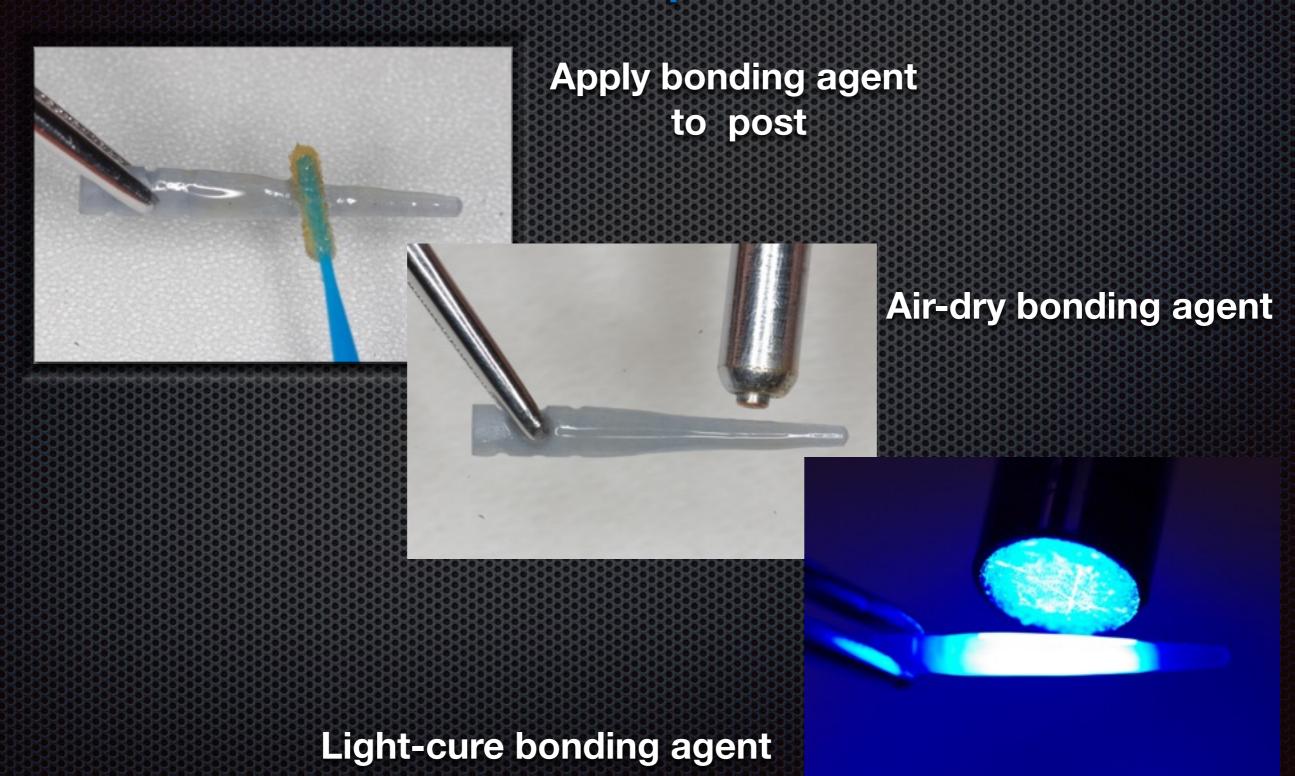
Try - in Oval Post

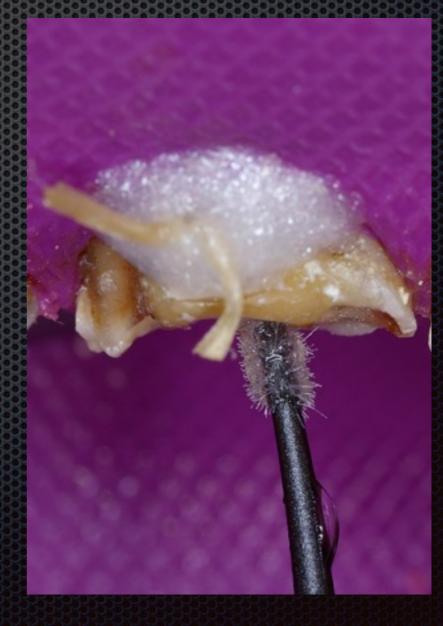
Acid-etch the space and tooth structure
Rinse away etchant, Remove excess water

Apply bonding agent/adhesive Light-cure all adhesive

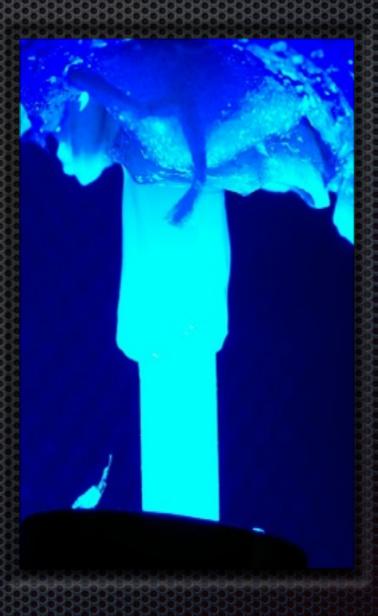
Place cement and then post

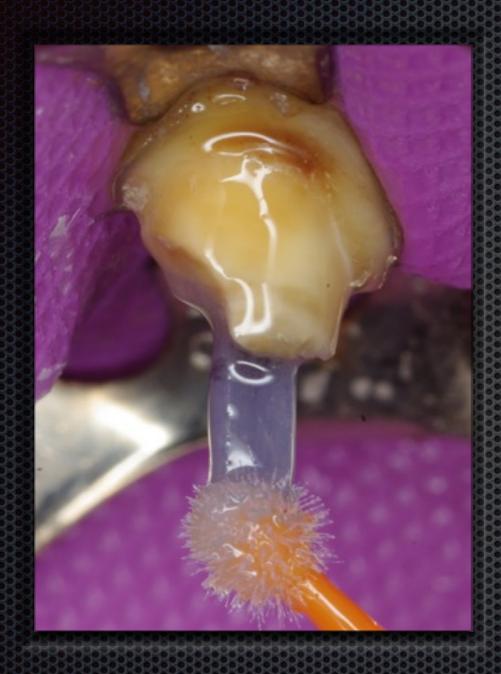
Light-cure the cement

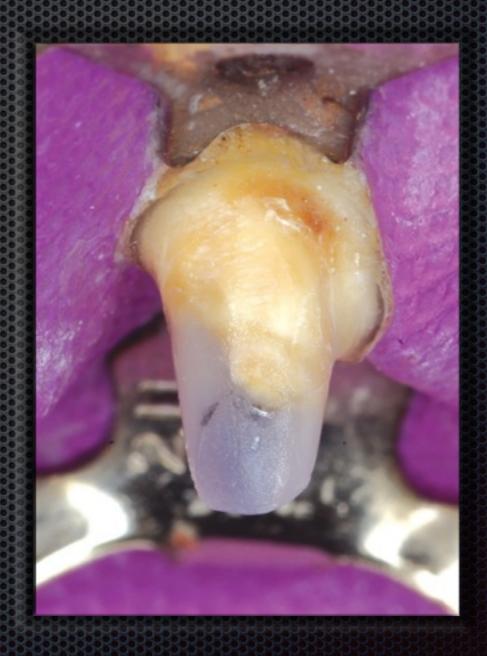
Apply bonding agent/adhesive

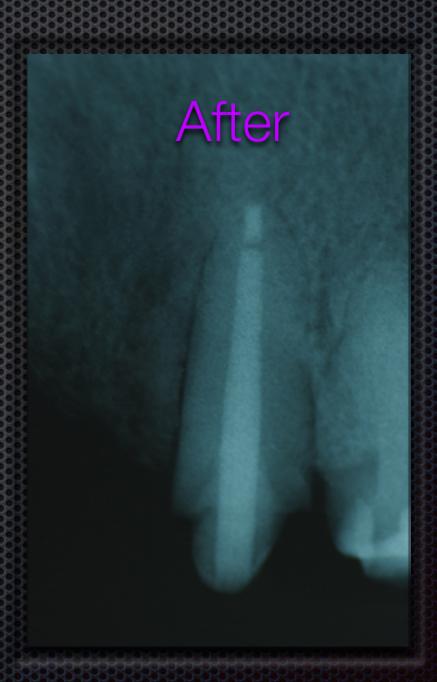
Final Radiograph
